RANGE ROVER V8 LOSING ITS COOL? DON'T BLOW YOUR TOP

Chris Crane of Rpi Engineering explains what's happening at the heart of the eight-pot legend

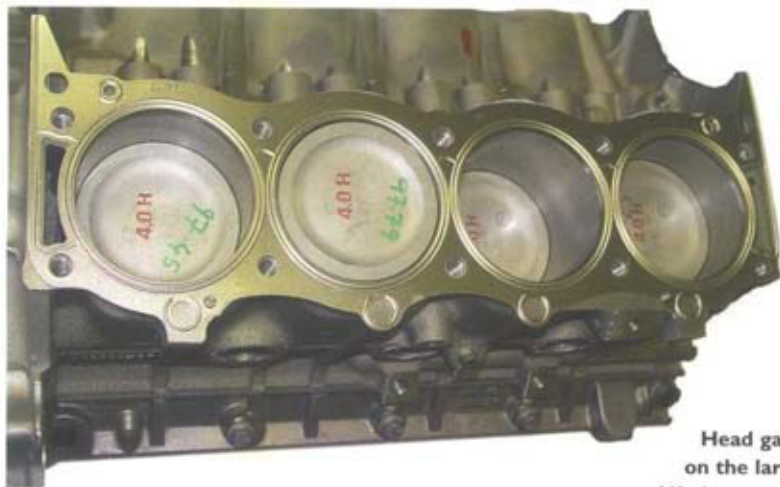
Head gasket failure on the large capacity V8s is more likely to be a result of coolant loss, rather than the cause

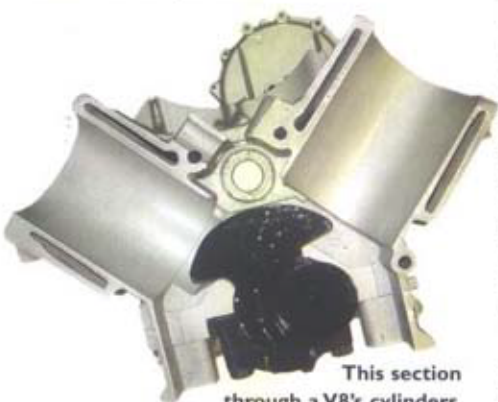
This section through a V8's cylinders

shows the thickness of material between the coolant space and the cylinder wall against which the liner fits

Coolant passages inside the Rover block casting are designed to run as close as possible to the cylinder liner in order to maximise heat transfer from cylinder to coolant. This means the wall of the block, where the liner slides in, is relatively thin.

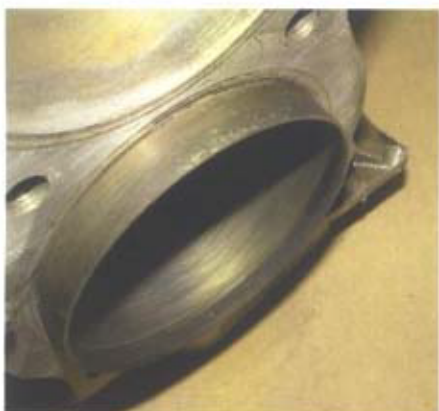
This engine was tilted while being pre-heated for a pressure test. Expansion of block made this loose cylinder liner slide part-way out

Unless the crack has been allowed to develop for a protracted period, it will only open when the block expands as the engine warms up. An engine that has been stripped for pressure test will be cold, and the crack will be closed up tight and unlikely to show any leakage. The only reliable way to detect cracking is by first heating the block up to its normal working metal temperature and then performing the pressure test.

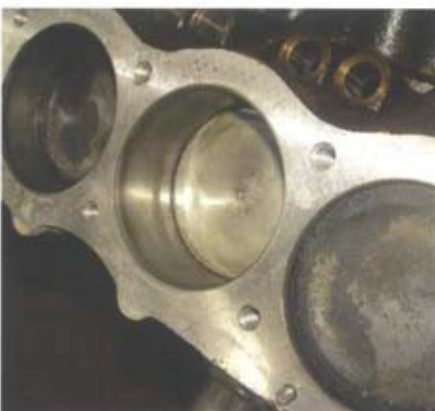
The centre piston here has been 'steam cleaned' by coolant escaping at the top of the liner and vaporising in the engine heat

When the engine is switched off, the coolant system will remain pressurised, but the cylinder will lose pressure through the partly open exhaust and/or inlet valves. Coolant can then leak into the cylinder under its own pressure to be vaporised by the residual heat in the cylinder. It then drifts through the valve ports, leaving no visible sign.

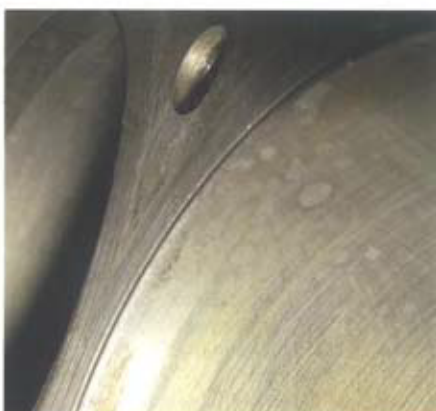
A loose liner can be hard to detect. The top edge should be flush with the block surface – this one has dropped marginally lower

Unfortunately, it's just not practical to replace a slack liner. If one liner has been loosened by overheating, it's a near certainty that the remaining liners will have been similarly affected and could break loose at any time.

It's not remotely cost-effective to replace and machine eight cylinder liners – the only realistic option is a replacement engine.

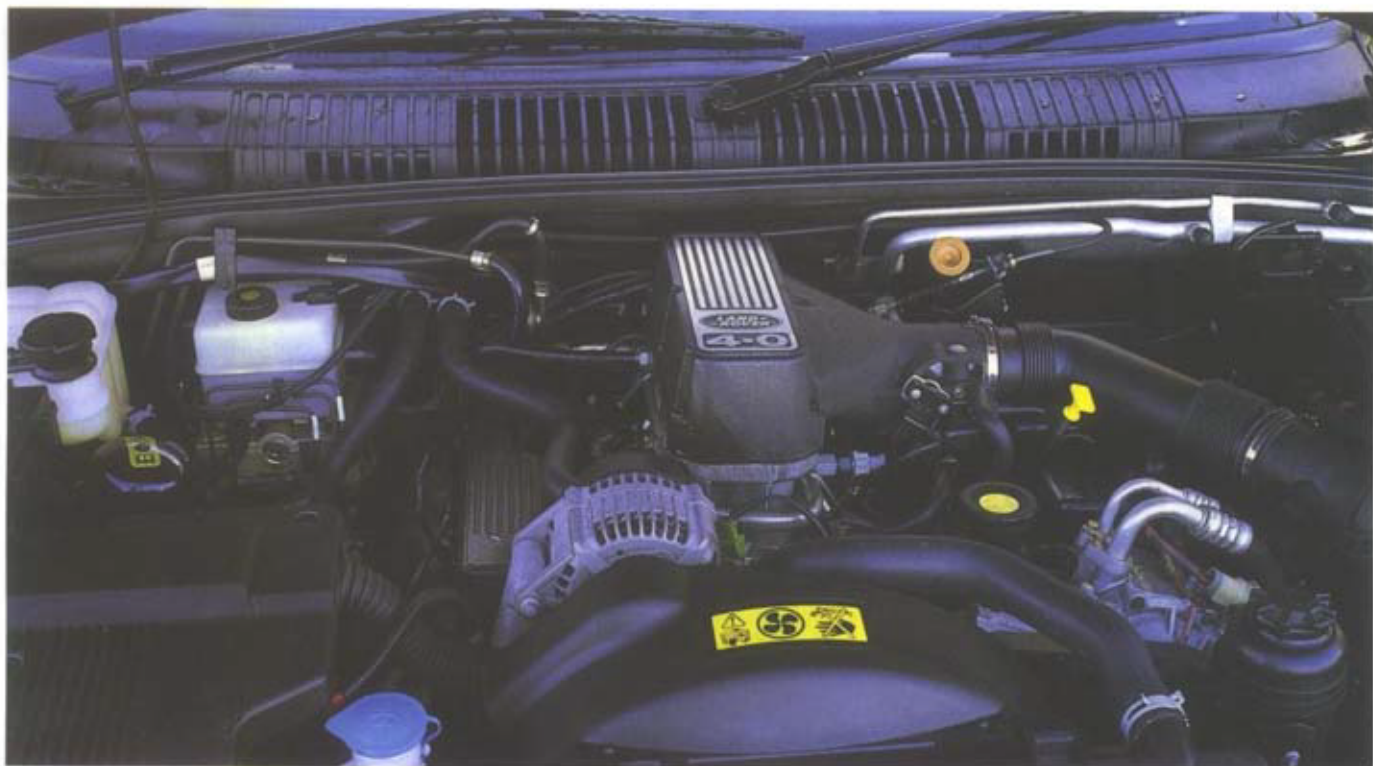
Out of all the later long-stroke V8 motors, the 4.0-litre unit (above) appears less prone to cracking than the higher-torque 4.6-litre engine

These engines both use the same block casting. The key lies in the torque outputs: the longer-stroke 4.6 produces more torque than the 4.0-litre unit.

When towing a heavy trailer on a long climb, the less-potent 4.0-litre Range Rover would kick down a gear, putting the engine revs into the higher, safer range. But in a similar situation, the meatier 4.6 would tend to stay in a higher gear, therefore maintaining lower engine revs in the critical area of the fuel map and, subsequently, higher metal temperatures.

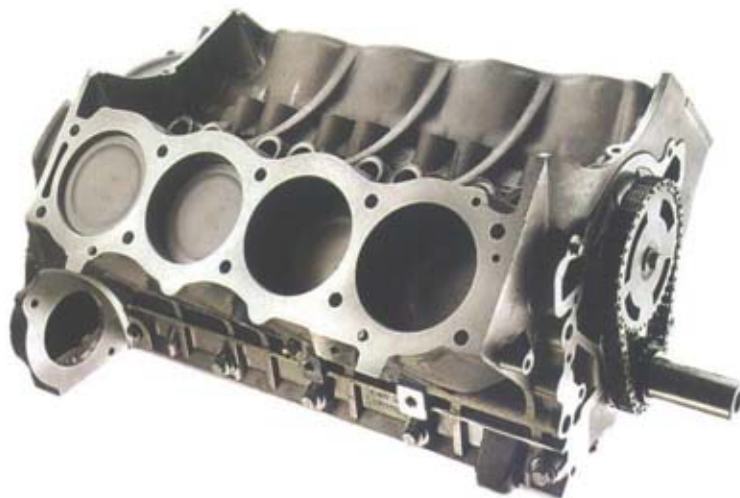
Coolant leakage problems from cracks in the cylinder block are associated mainly with the large-capacity derivatives of the Rover V8
